## Session C3 - Fish Passage Restoration at the Briggsville Dam: Using Sediment Transport Analysis for Natural Channel Design

Jessica Louisos  
*Milone & MacBroom, Inc.*

# FISH PASSAGE RESTORATION AT THE BRIGGSVILLE DAM: USING SEDIMENT TRANSPORT ANALYSIS FOR NATURAL CHANNEL DESIGN

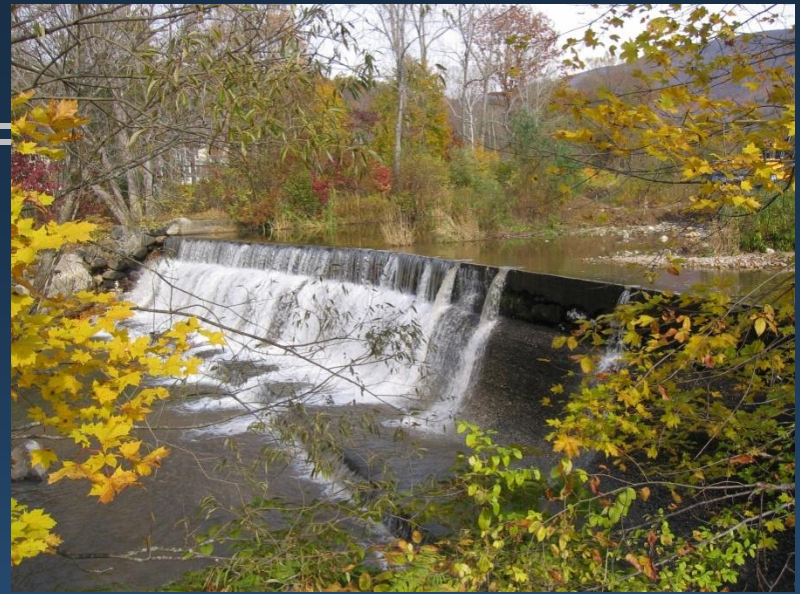
- Remove Briggsville Dam
  - 15 feet high
  - 145 feet long
  - Concrete structure
- Reconnect 30 miles of headwater streams along the North Branch of the Hoosic River
- Improve Fish Passage and Local Habitat for:
  - Eastern brook trout
  - Longnose sucker
  - Slimy sculpin
- Reduce flood risks associated with possible dam failure

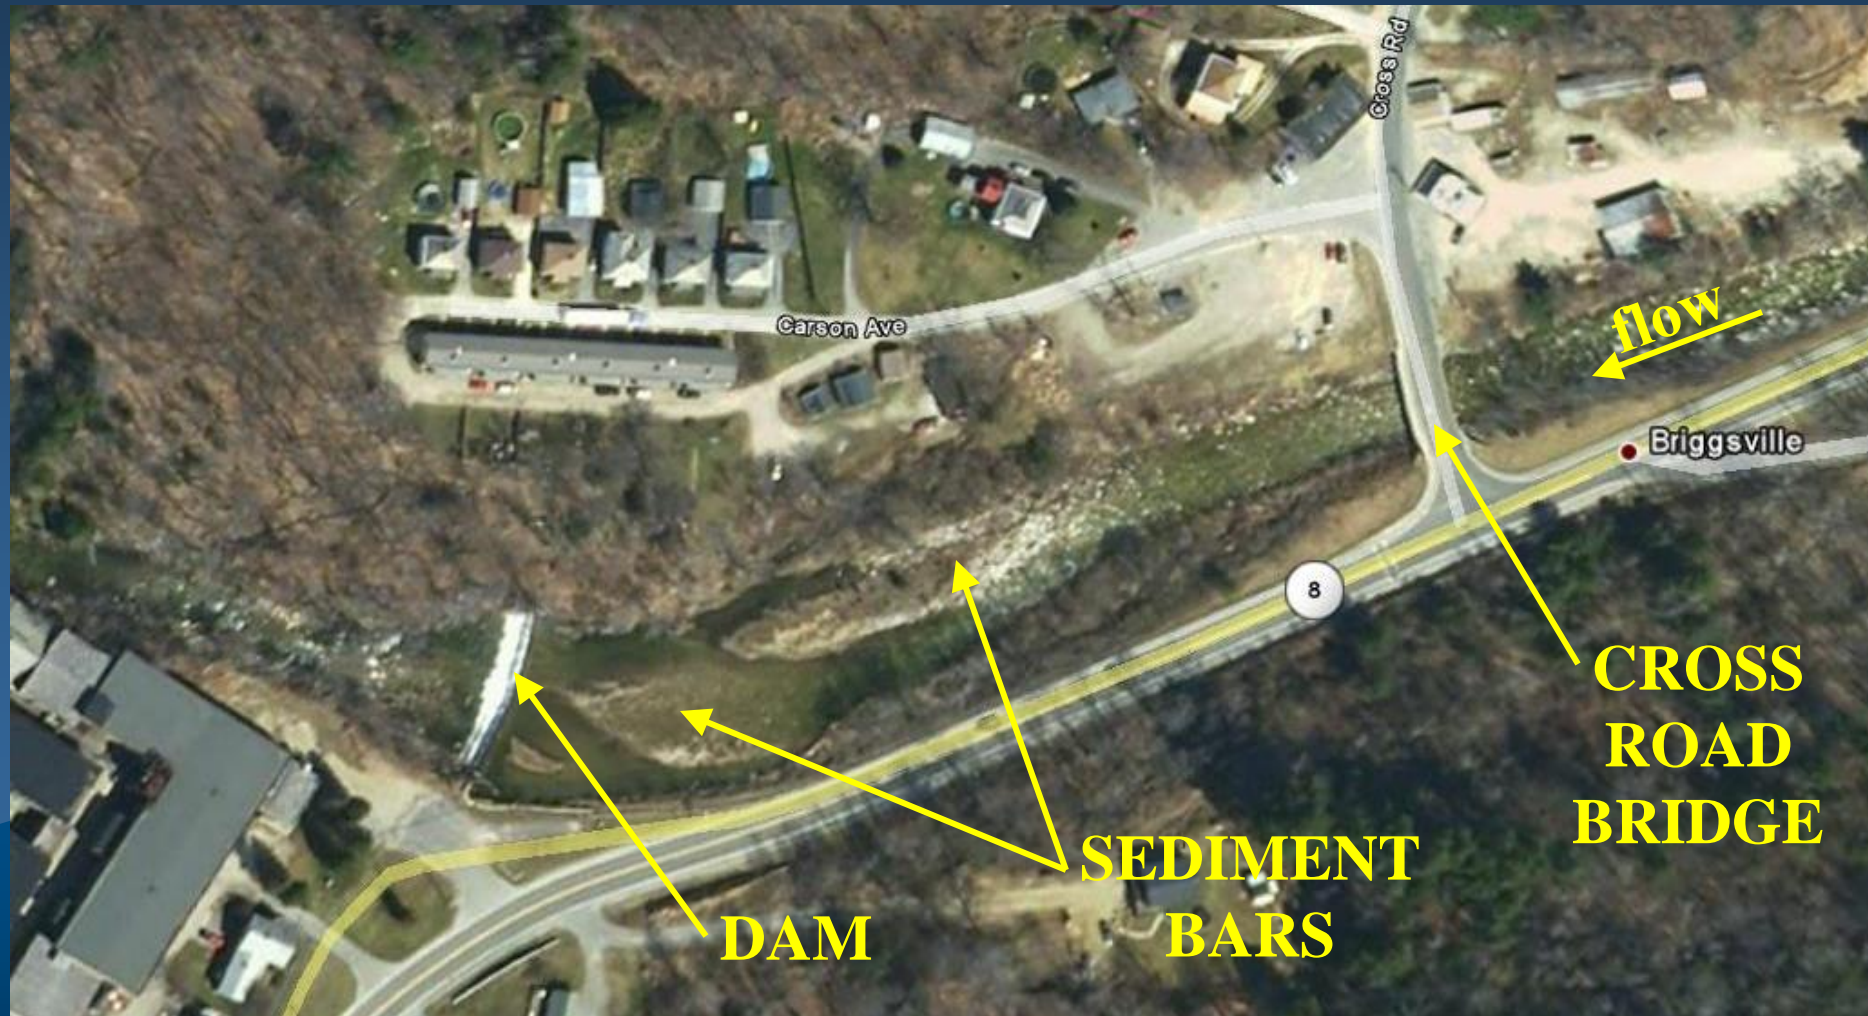
# PROJECT CONSTRAINTS

- Cross Road Bridge – 750 feet upstream
- Impoundment full of coarse sediment

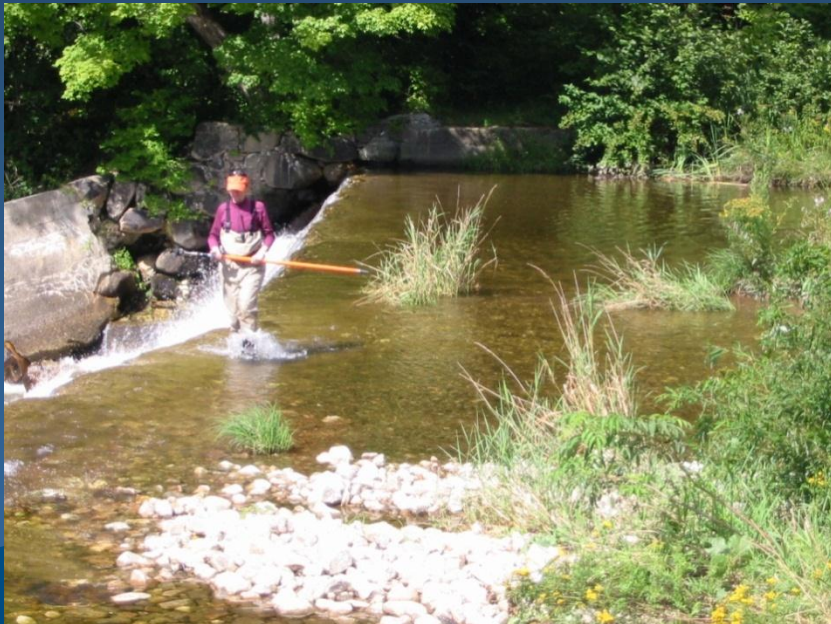
- Multiple reach geomorphic inspection and classification
- Substrate identification

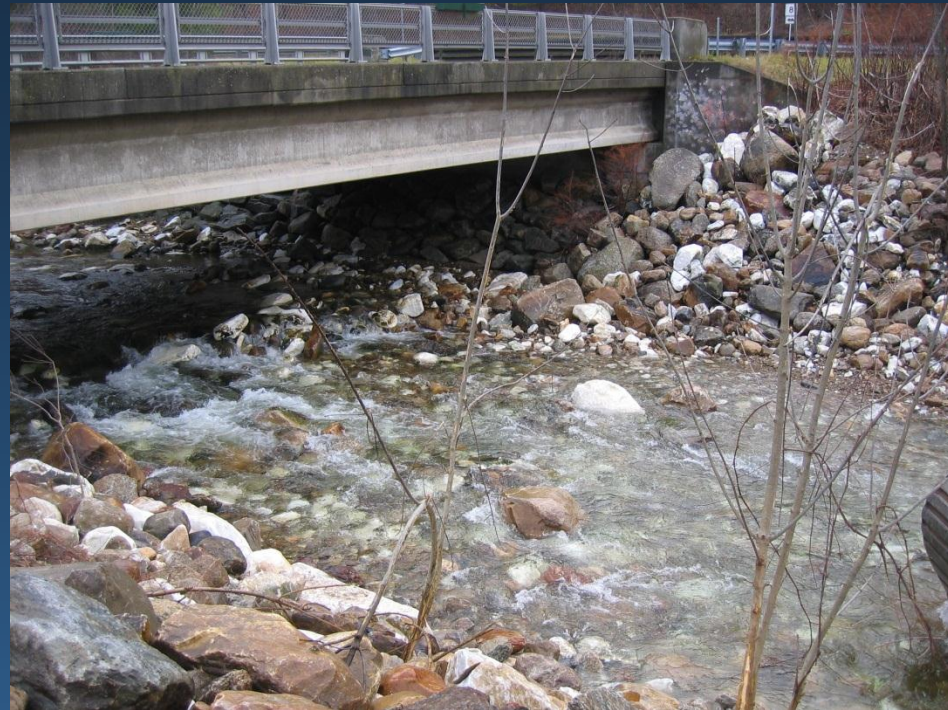
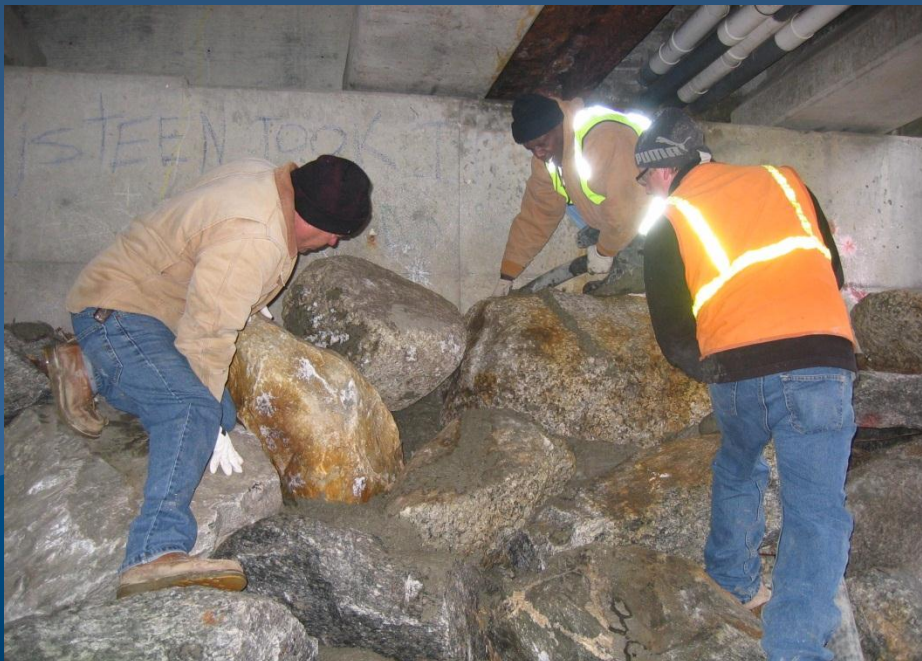
# BRIDGE SCOUR COUNTERMEASURES

- Extend existing riprap to top of bank
- Add toe boulders to deflect and break up flow path
- Grout between existing riprap under bridge

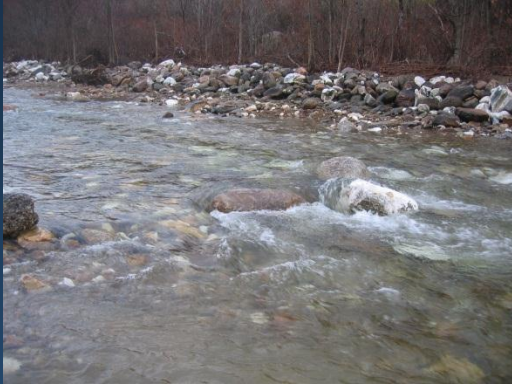
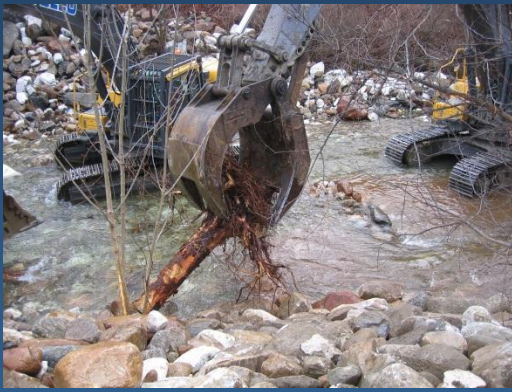
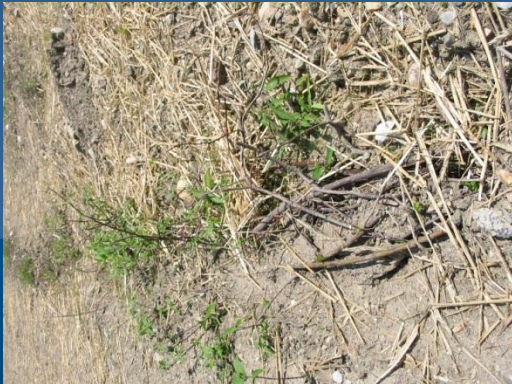
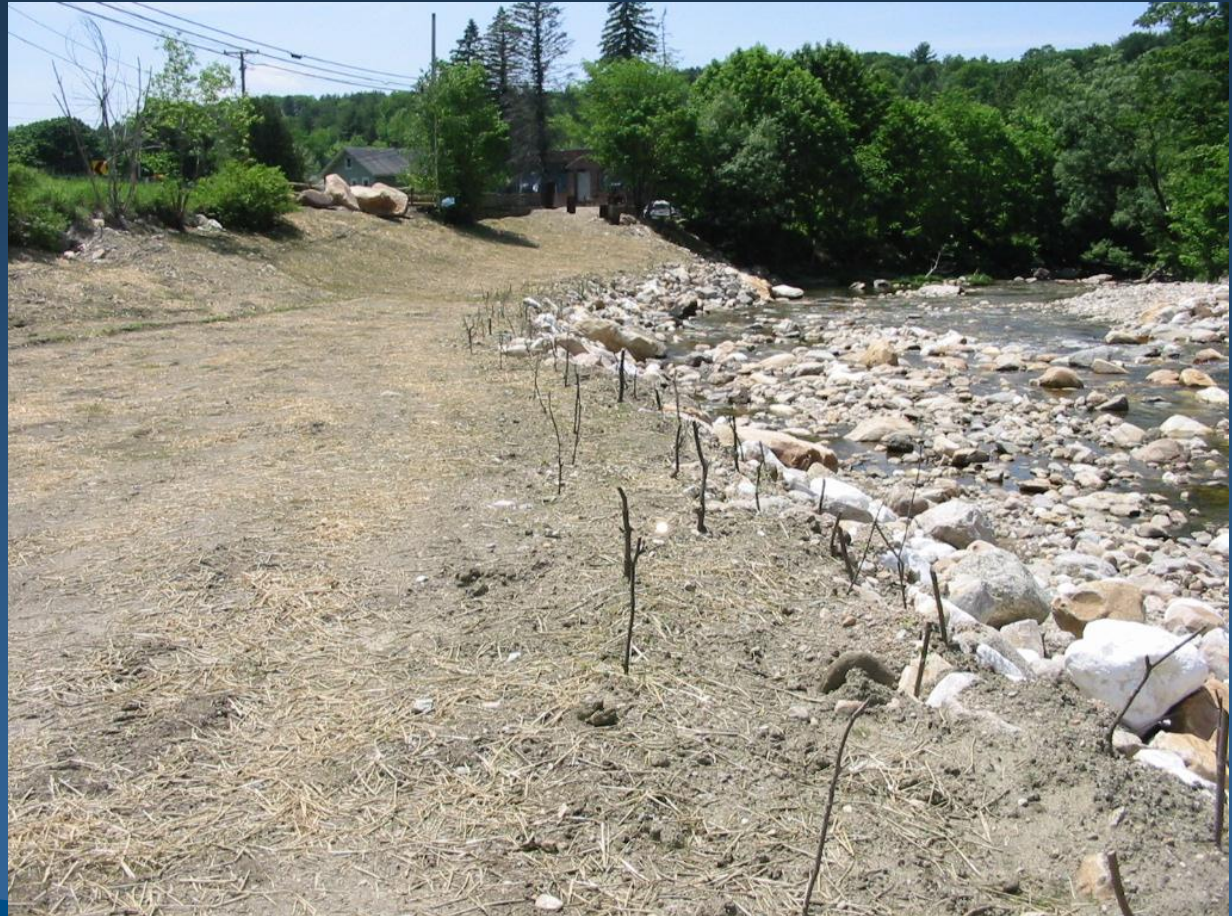
# RESTORATION

- After spring floods:
  - upstream unchanged
  - downstream aggraded 0.5 feet
- After Tropical Storm Irene:
  - upstream degraded 1.5 feet
  - downstream degraded 3.5 feet

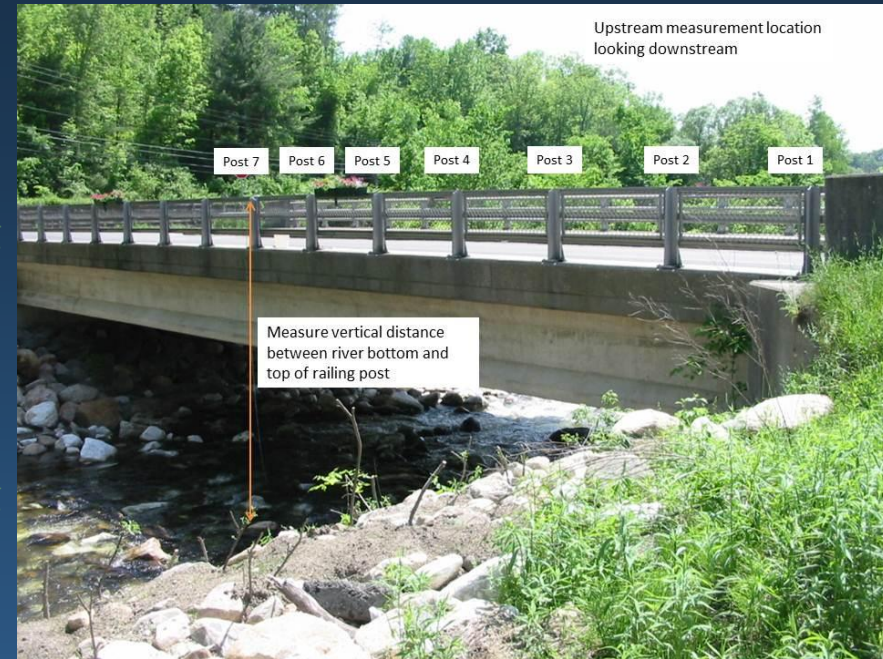
# DEGRADATION MONITORING

Date	Upstream	Downstream	Notes
November 1, 2010	19.7	20.6	No change during next three weekly measurements.
November 29, 2010	20.2	20.3	Midway through dam removal process
December 2, 2010	20.0	20.3	After large December 1 flood.
December 6, 2010	19.8	22.0	End of river construction
April 8, 2011	19.7	22.0	Beginning of vegetation planting
May 31, 2011	19.7	21.5	After Spring Flooding
November 2011	21.2	25	After Tropical Storm Irene
